JUNE 2020

COMMUNITY PEDESTRIAN AND BICYCLE SAFETY TRAINING 2020

**Altadena On-Bike Assessment Follow-Up
Activity**

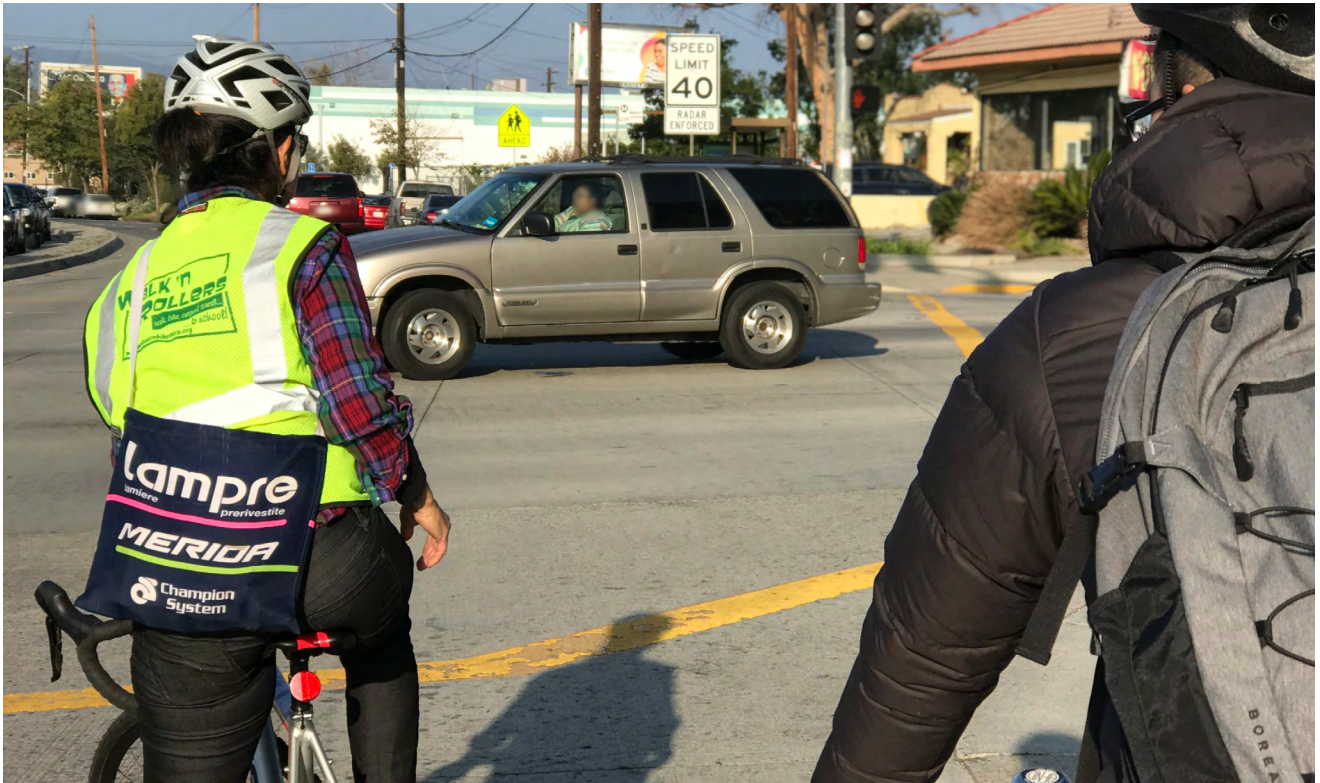
- There is no bicycle infrastructure along Ventura Street and Fair Oaks Avenue.
- The bike lane ends suddenly on Woodbury Road approaching Lincoln Avenue which has a posted speed limit of 40 miles per hour. Participants shared that they feel unprotected from vehicle traffic once the bike lane ends.

Top: Participants wait at the signal to continue down Woodbury Road past Lincoln Avenue. Bottom: Participants stop to discuss concerns and opportunities at Fair Oaks Avenue and Ventura Street.

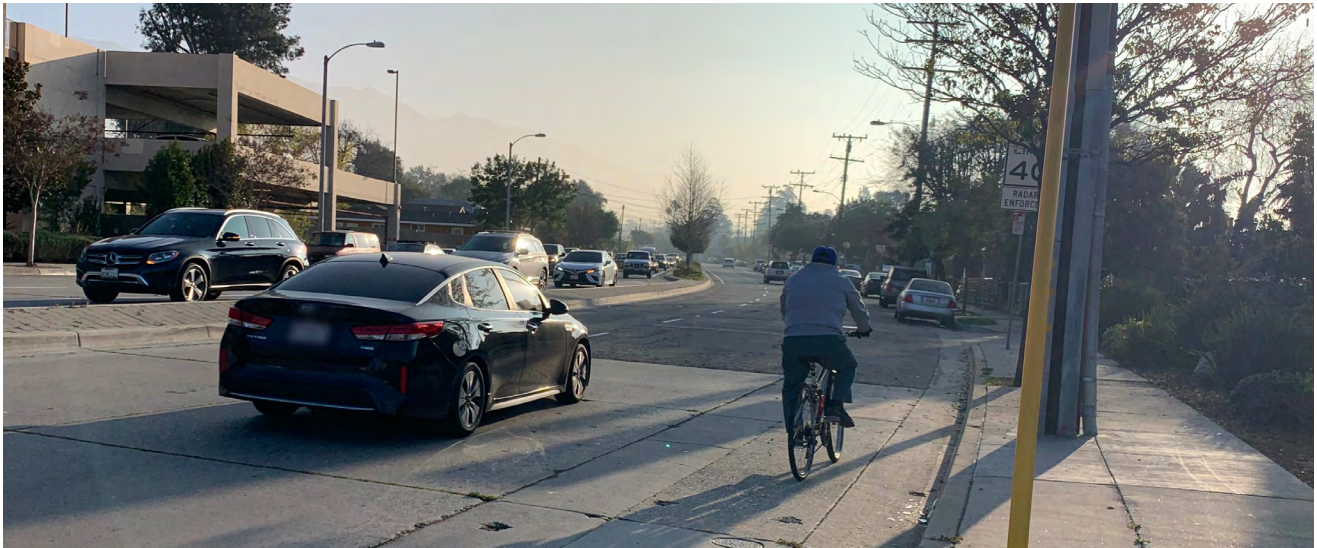
- Drivers make wide and fast turns into the intersection of Lincoln Avenue and Woodbury Road.
- Drivers often fail to stop before making a turn at all legs of the intersection of Lincoln Avenue and Woodbury Road or stop within the crosswalk which makes it difficult for pedestrians and bicyclists to cross the intersection. Participants noted that this intersection is a high traffic area for all modes with transit stops on the corners, bike lanes on Woodbury Road, and Lincoln Ave and Woodbury Road that serve as connectors to various destinations. Community members also notice the most collisions in this area.

Top: Participants continue down Woodbury Road after discussing concerns and opportunities at Woodbury Road and Lincoln Avenue. Bottom: Participants bike down East Calavera Street which is set to be a planned bike route.

- Expanded bike lanes on Woodbury Road all the way to Lake Avenue.
- Improve bike sensors at the intersection of Woodbury Road and Lake Avenue.
- Traffic calming measures such as bulb outs at Lincoln Avenue and Woodbury Road and buffered bike lanes along Lincoln Avenue would improve safety for riders.
- Installation of bike boxes at Woodbury Road and Lincoln Avenue and Woodbury Road and North Marengo Avenue would provide a safer place for bicyclists to wait.

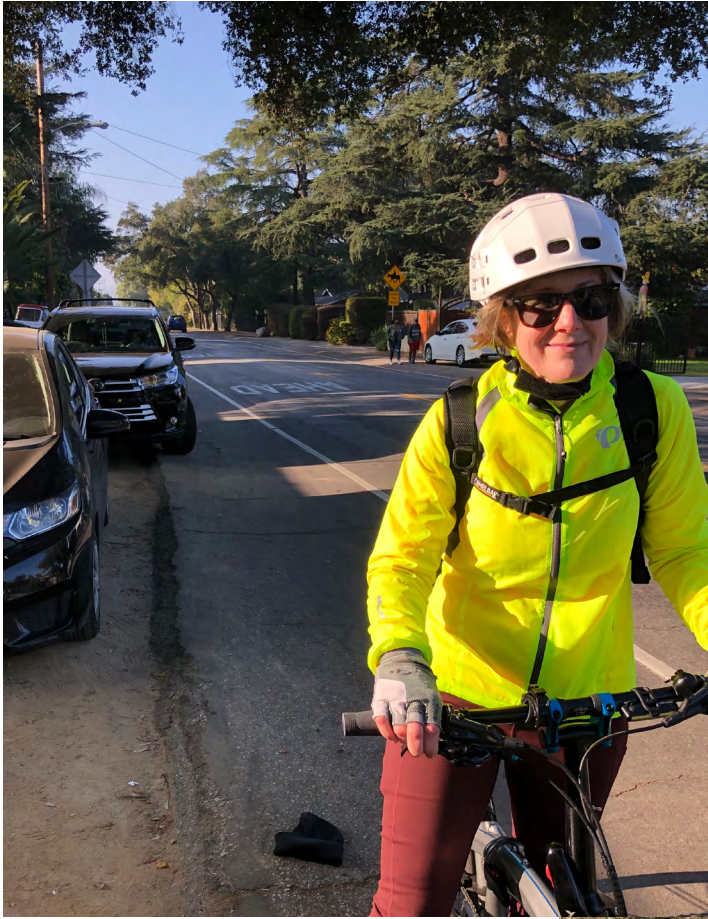
difficult for drivers to pass bicyclists because of vehicle traffic in both directions. Drivers expressed impatience with bicyclists taking the full lane. Because of this, some bicyclists preferred to ride on the paved shoulder rather than share the road with drivers. However, trash cans and parked cars in the paved shoulder and the travel lane impeded the bicyclists' path, which made them weave in and out of the travel lane. This was further complicated by the number of parents and students walking and biking to and from school on the paved shoulder. All these different users sharing the road and paved shoulder created visibility issues and potential conflict points.

A bicyclist pulls over at the paved shoulder on Casitas Avenue, just south of West Altadena Drive. Bicyclists, pedestrians, skaters, and parents walking with strollers on their way to Odyssey Charter School will need to compete for travel space on the paved shoulder.

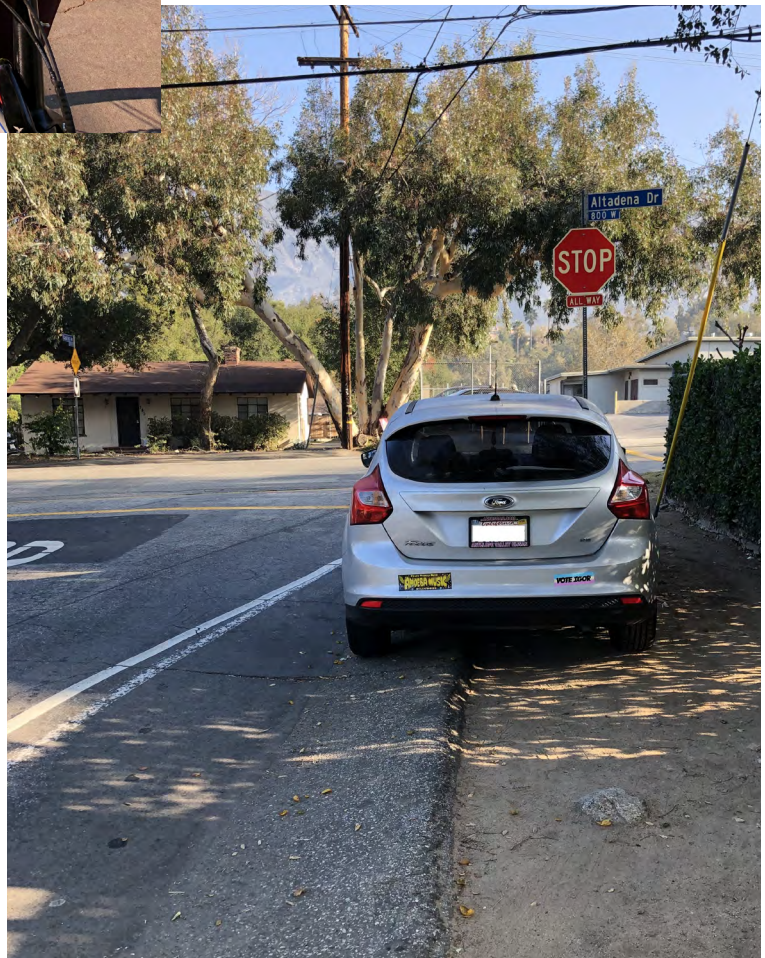
A parked car on Casitas Avenue, just south of West Altadena Drive, obstructs the paved shoulder and forces pedestrians, bicyclists, skaters, and parents with strollers into the street.
