JUNE 2020

COMMUNITY PEDESTRIAN AND BICYCLE SAFETY TRAINING 2020

**Altadena On-Bike Assessment Follow-Up
Activity**

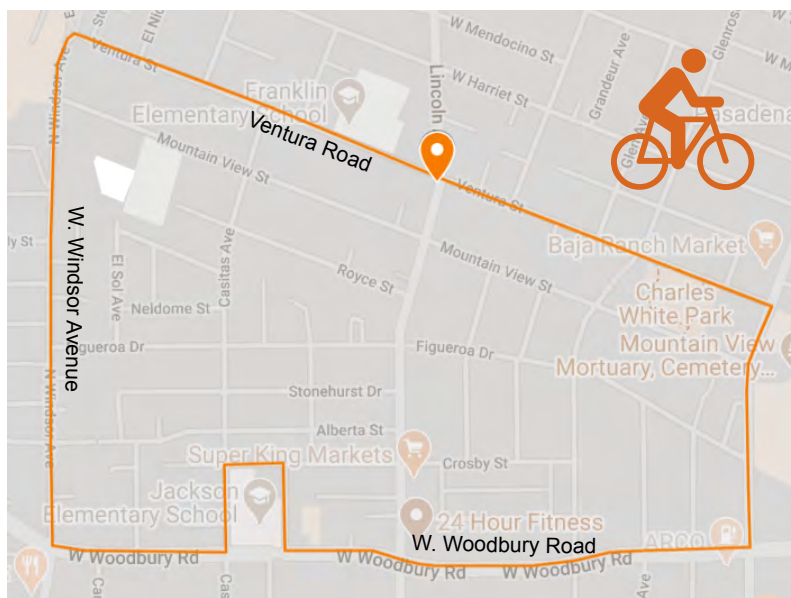
On-Bike Assessment Route 1

- Drivers appear to travel above the posted speed limits or above what is safe for roadway conditions along Ventura Street, Lincoln Avenue, Fair Oaks Avenue, Woodbury Road, and Windsor Avenue. Participants felt that the roadway design encourages driver speeding.

- Bicyclists experience right-turn conflicts with drivers at the intersection of Fair Oaks Avenue and Woodbury Road.
- There are conflicts between drivers and bicyclists at the intersection of Figueroa Drive and Windsor Avenue; this is expected to become a four-way signalized intersection in the future. The current roadway design causes commuter backups along Figueroa Avenue to Casitas Avenue and along Windsor Avenue on the weekdays.

- Participants shared they are concerned for their safety when riding along Fair Oaks Avenue between Ventura Street and Woodbury Road due to downhill slope, roadway conditions, speed and unsafe behavior of drivers. The overall conditions create potential conflict points with drivers and the slope and speed of cars results in drivers not being aware of bicyclists driving alongside them.

- Casitas Avenue is a safer north-south corridor than Lincoln Avenue and Fair Oaks Avenue due to less vehicle traffic and slower speeds and more residential scale.
- Windsor Avenue from Figueroa Drive to Ventura Street can be improved for pedestrian and bicycle safety.

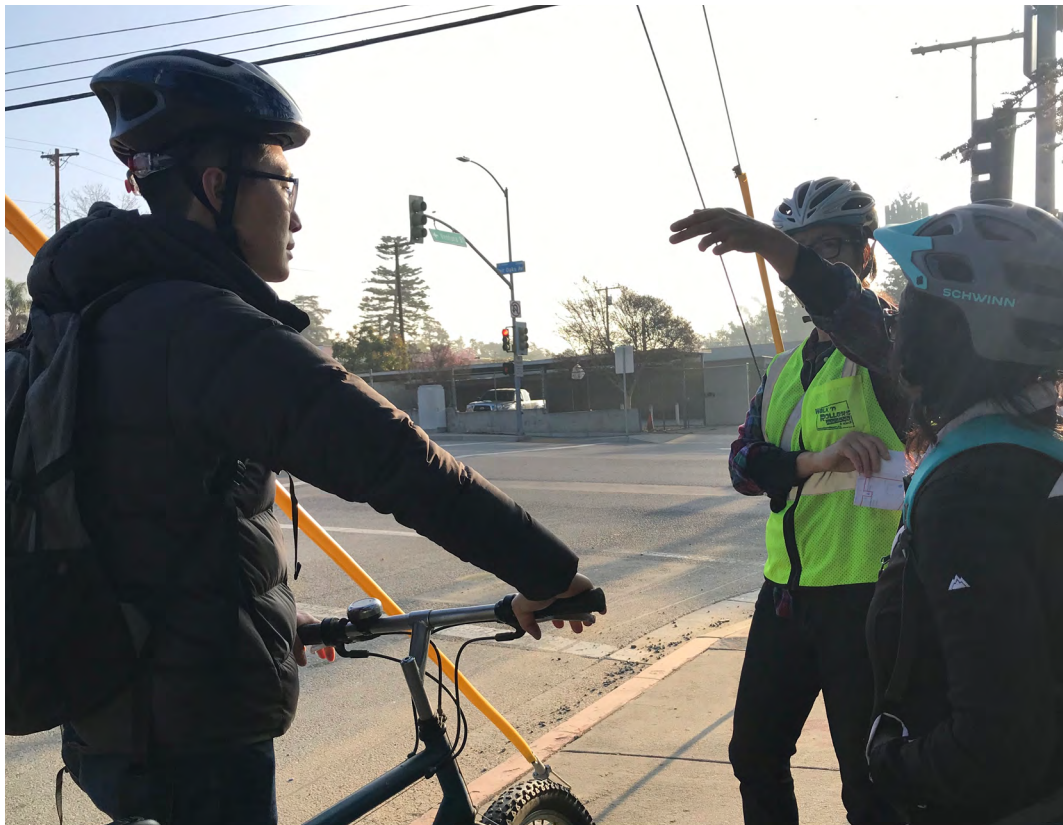
Top: Participants wait at the signal to continue down Woodbury Road past Lincoln Avenue. Bottom: Participants stop to discuss concerns and opportunities at Fair Oaks Avenue and Ventura Street.

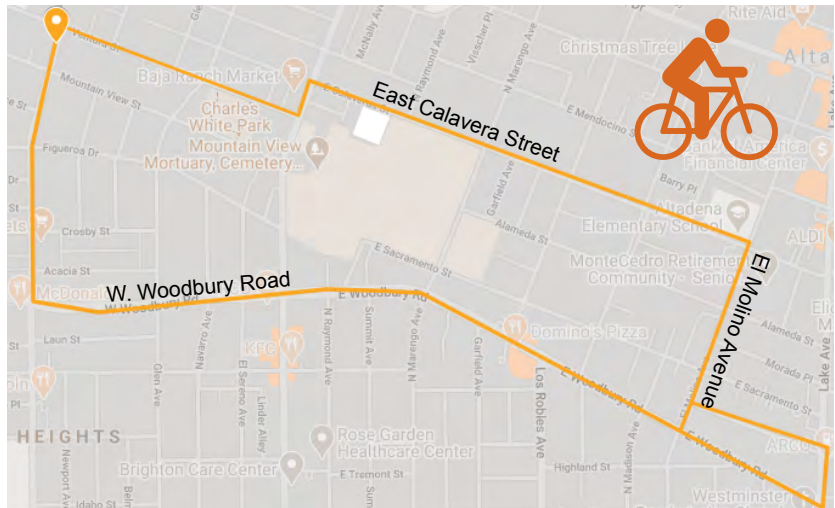
On-Bike Assessment Route 2

- Drivers use the middle turn lane on Lincoln Avenue to pass bicyclists instead of sharing the road; this causes bicyclists to feel unsafe traveling along Lincoln Avenue.

- Drivers make wide and fast turns into the intersection of Lincoln Avenue and Woodbury Road.
- Drivers often fail to stop before making a turn at all legs of the intersection of Lincoln Avenue and Woodbury Road or stop within the crosswalk which makes it difficult for pedestrians and bicyclists to cross the intersection. Participants noted that this intersection is a high traffic area for all modes with transit stops on the corners, bike lanes on Woodbury Road, and Lincoln Ave and Woodbury Road that serve as connectors to various destinations. Community members also notice the most collisions in this area.

- Unsafe roadway conditions including lack of bicycle lanes, the high speed of cars, and wide lanes make it difficult for bicyclists to ride on Lincoln Avenue.
- Woodbury Road has a Class II Bike Lane that ends right before Santa Anita Avenue.
- The lack of clear lanes, crosswalks, and low visibility for bicyclists make the intersection of Woodbury Road and Highland Street difficult for bicyclists to navigate, especially when making left turns.

- Residential dumpsters block the bike lane on West Woodbury Road
- Navigation applications, such as Waze, direct drivers to cut through residential streets that offer a lower stress option for bicyclists.
- Participants expressed concern about higher traffic volume that will come with the expansion of a daycare on Woodbury Road between North Marengo Avenue and Santa Anita Avenue. Participants noted that existing traffic during arrival and dismissal causes drivers to queue up in the bike lane.

- Expanded bike lanes on Woodbury Road all the way to Lake Avenue.
- Improve bike sensors at the intersection of Woodbury Road and Lake Avenue.
- Traffic calming measures such as bulb outs at Lincoln Avenue and Woodbury Road and buffered bike lanes along Lincoln Avenue would improve safety for riders.
- Installation of bike boxes at Woodbury Road and Lincoln Avenue and Woodbury Road and North Marengo Avenue would provide a safer place for bicyclists to wait.

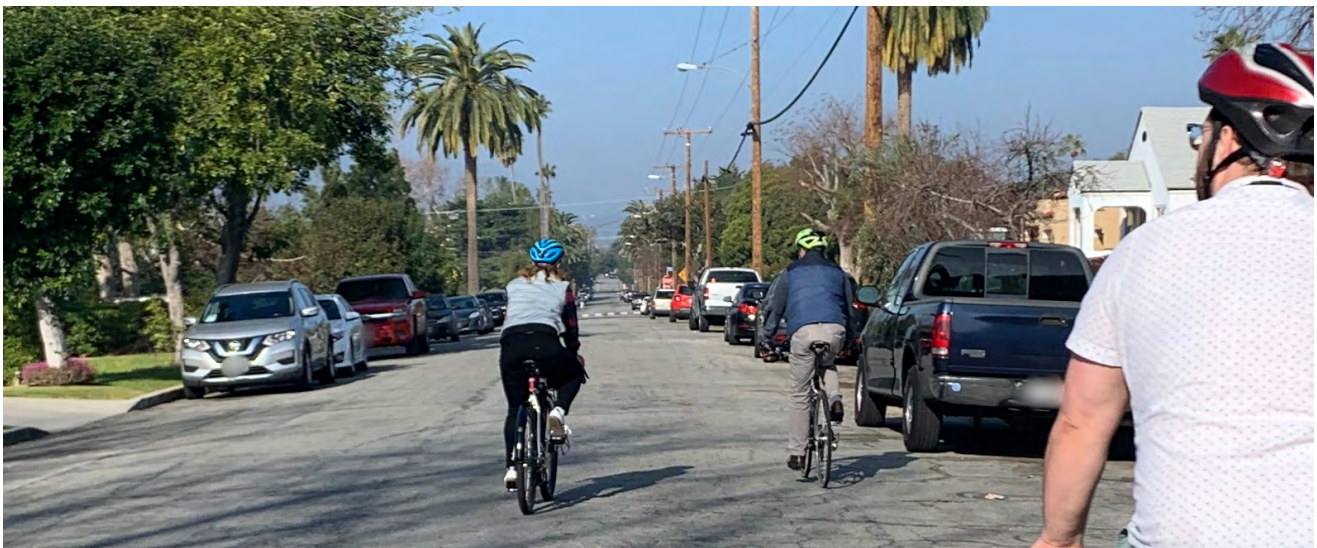
Top: Participants continue down Woodbury Road after discussing concerns and opportunities at Woodbury Road and Lincoln Avenue. Bottom: Participants bike down East Calavera Street which is set to be a planned bike route.

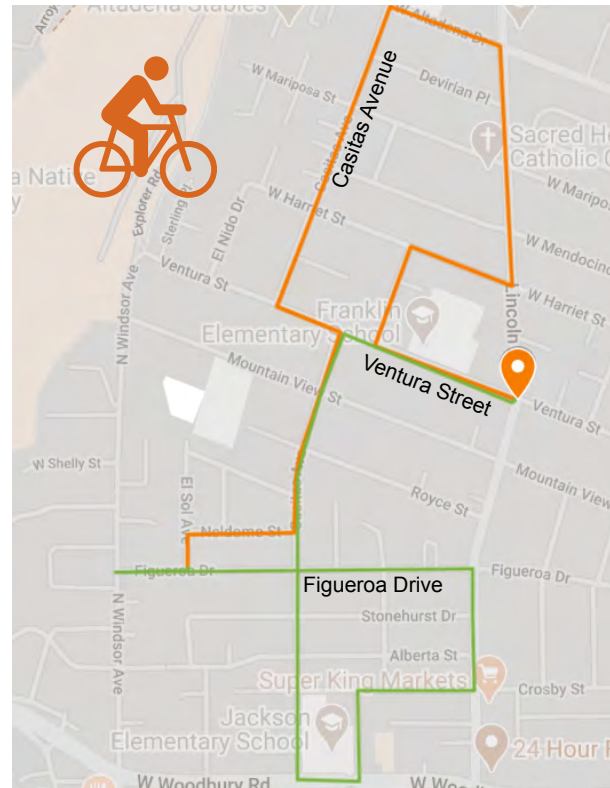
On-Bike Assessment Route3

- Many large trailers appear to drive above the posted speed limit downhill on Lincoln Avenue.
- Many drivers used the middle left turning lane to pass bicyclists on Figueroa Drive; participants felt unsafe with cars passing.

- Cracked pavement along Casitas Avenue made bicyclists weave in and out of the travel lane, making their riding less predictable.
- The sidewalk ends abruptly at the intersection of Figueroa Drive and North Windsor Avenue.
- Crosby Street is a narrow street and less comfortable to ride on than Lincoln Avenue, which is wider and has fewer blind spots.
- On Casitas Avenue, at Calaveras Street, there are street signs for sharing the road with horses, but not for bicyclists.
- Bicyclists felt that the first school speed limit sign on Casitas Avenue, at Devirian Place, was too close to Odyssey Charter School to let drivers know to slow down for people walking and biking to school.

- Speed bumps along Ventura Street slowed vehicle traffic, which made it more comfortable for bicyclists to ride alongside drivers.
- At the intersection of Crosby Street and Lincoln Avenue, the crossing guard directed driver, pedestrian, and bicyclist traffic, which added a sense of safety for bicyclists.
- Many drivers observed the three-foot rule and slowly passed bicyclists in the opposite lane along Casitas Avenue.
- Participants enjoyed that there were people out, walking and shopping along Lincoln Avenue.
- There were nice shade trees on Casitas Avenue, north of Ventura Street, which provided shade for bicyclists while riding uphill.
